MEASUREMENTS ON THE RESISTANCE OF FLEXIBLE PACKAGING MATERIALS TO PUNCTURE, ABRASION, AND FLEXURE AND THE RELATIONSHIP OF THESE MEASUREMENTS TO THE PERFORMANCE OF PACKAGES SUBJECTED TO CONDITIONS CAUSING PINHOLE FORMATION

Kwoh H. Hu

January 1973

UNITED STATES ARMY
NATICK LABORATORIES
Natick, Massachusetts 01760

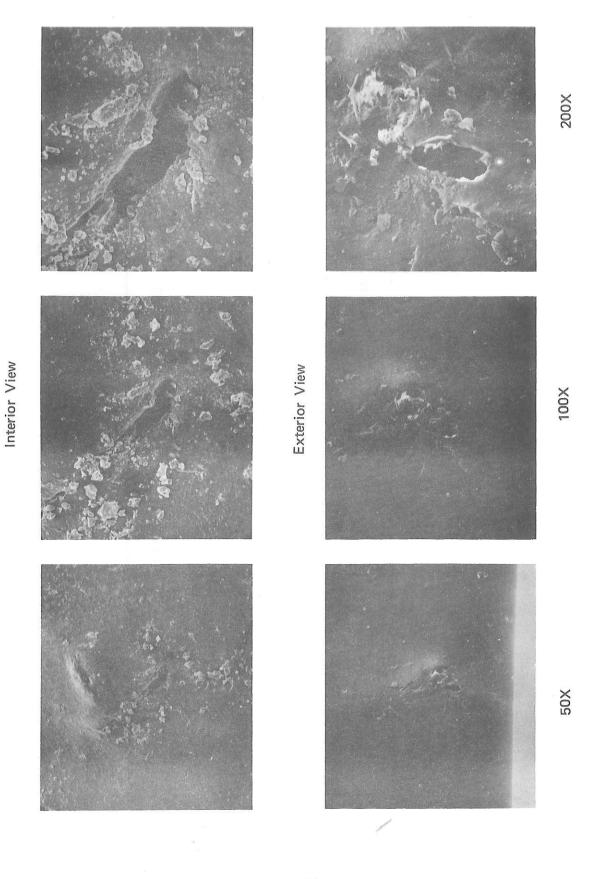
Examinations made and pictures taken by using the scanning electron microscope indicated that the abrasion damage (friction between the hard edge of the freeze-dried product and the package) was the main factor in causing the package failure. This is consistent with the finding that the probability of package failure in the field has an excellent rank correlation coefficient with abrasion resistance and puncture resistance factors of materials determined in the laboratory.

Figure 12. Scanning Electron Microscope Examination of Damaged Sample 2.0-mil Nylon-6/0.35-mil Al. Foil/3.0-mil Polyolefin

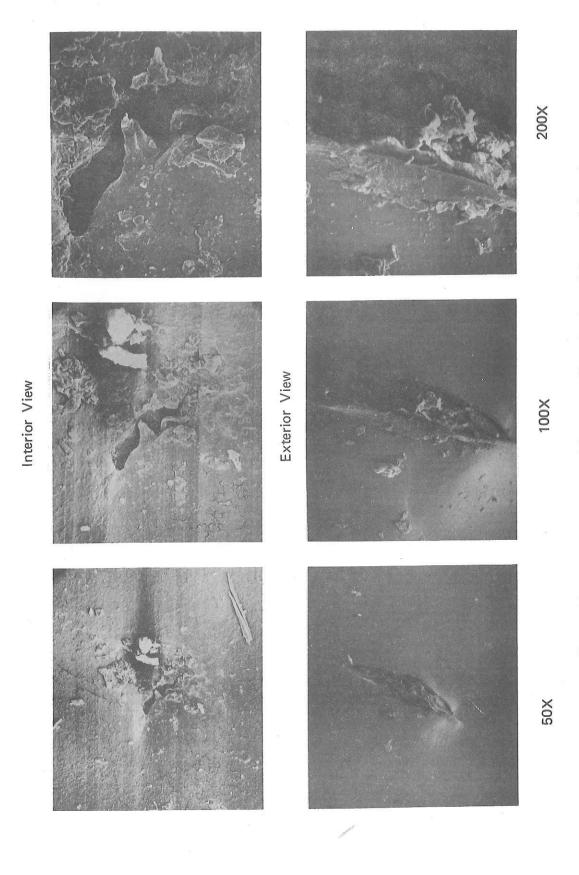
Pictures were taken under the scanning electron microscope. For comparison purposes, the first set of pictures was taken of the inside surface of the sample of a failed package and then of the outside surface of the sample package. Magnifications were 50X, 100X, and 200X. Figures 12 to 16 show the damage area of the five types of package filled with freeze-dried spaghetti with meat sauce. The top row of pictures shows the interior view of the damage area, while the bottom row shows the exterior view. They all seemed to have well defined holes or openings from the interior view, but smaller and sometimes partial openings from the exterior view. Moreover, in some cases, plastic laminates forming the packaging materials seemed to have been pushed out from the interior, causing them to form broken levers opening outward. These effects are especially apparent in Figure 13 and Figure 14.

Figure 13. Scanning Electron Microscope Examination of Damaged Sample of 0.5-mil Polyethylene Terephthalate/0.35-mil Al. Foil/3.0-mil Polyolefin

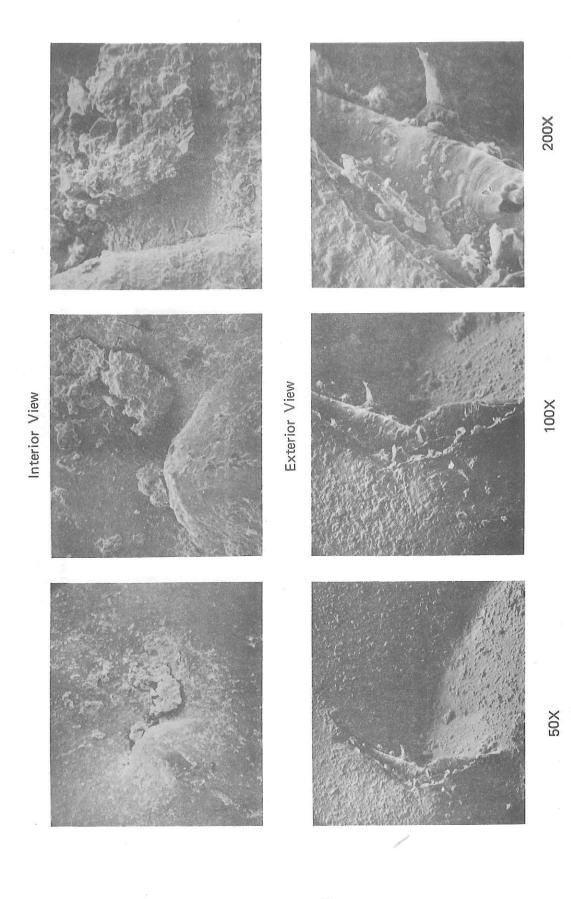
of 0.5-mil Polyethylene Terephthalate/0.35-mil Al. Foil/3.0-mil H.D. Polyethylene Figure 14. Scanning Electron Microscope Examination of Damaged Sample

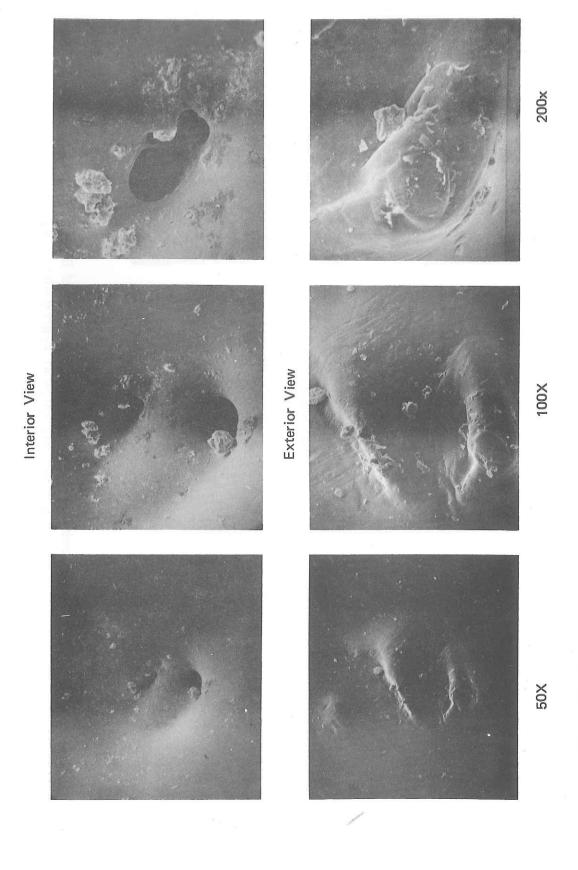
Figure 15. Scanning Electron Microscope Examination of Damaged Sample of 1.0-mil Nylon-6/10-lb L.D. Polyethylene/0.35-mil Al Foil/0.5-mil Polyethylene Terephthalate

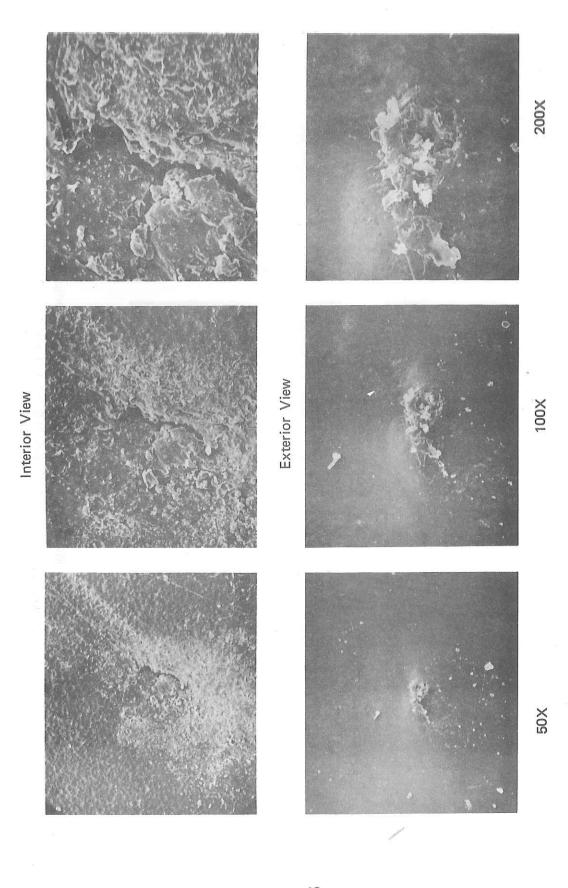
Figure 16. Scanning Electron Microscope Examination of Damaged Sample of 0.5-mil Polyethylene Terephthalate/0.35-Al. Foil/2.0-mil L.D. Polyethylene
